**Flood Control Project Maintenance  
Levee Inspections**

**Fall 2019 Levee Maintenance Deficiency Summary Report**

**Eastern Honcut Creek**

**Levee Inspection Report By Mile - Fall 2019**

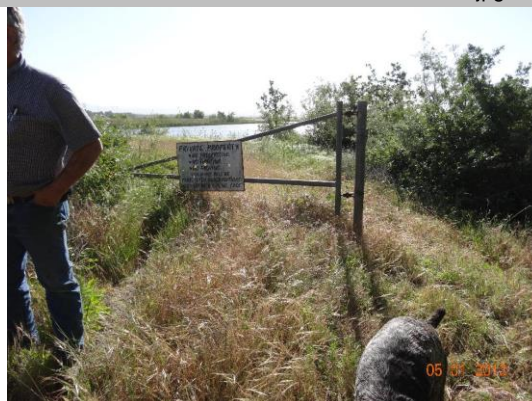
Photo 1 of 3 : UCIP\_FA\_2019\_52800\_24228.jpg

LM Start	0.01	Rating **	M	Issue No.	26
LM End	0.01	Issue Type +	Ma	Location *	
Category	Supplemental			GPS Latitude/Longitude	
				Start	End
Item	DRAFT DWR UCIP LMA Responsibility			39.298484 °	39.298484 °
				-121.569610 °	-121.569610 °
DWR ID	19167				
Comment Code					
Inspector Comment					
DS_ID:19167					
FS_ID:52800					
EP_NO: N/A					
Repair Type: Non-Urgent					
Crossing Status: Found					
UCIP Comments: 05/01/2013 Dense vegetation on landward side obstructs inspection. Vegetation needs to be cleared to perform utility crossing inspection. (DWR UCIP - O. Magana)					
FIELD_STRUCT_DESC: 24-inch corrugated metal drainage pipe through the levee, 12 feet below the crown. Flap gate located on the waterside (WS) end. [Additional Reference(s): DWR Levee Logs, 2005. USACE Sacramento O&M Manual Unit No. 151, November 1953, (Station 0+60)]					
FS Date: 5/1/2013

View of crown looking east.

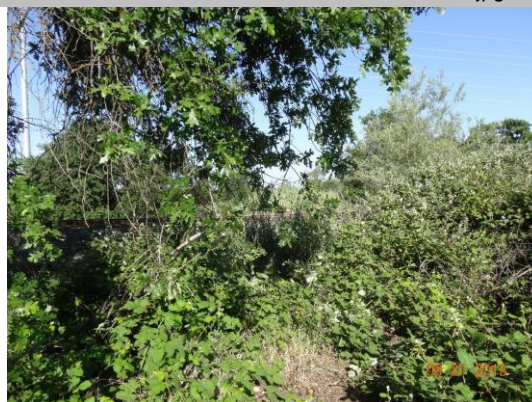
Photo 2 of 3 : UCIP\_FA\_2019\_52800\_24225.jpg

View of railroad looking west of crossing.

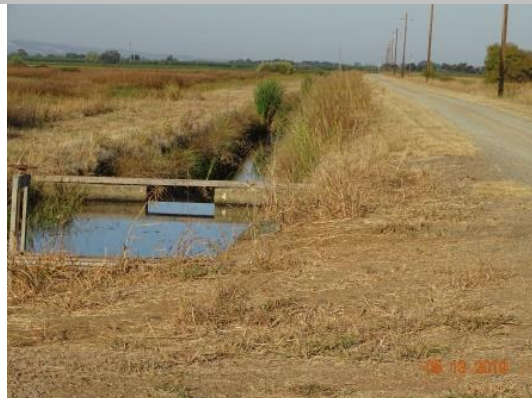
Photo 1 of 1 : FA\_2019\_NA0006\_252\_11\_20190916\_00026.jpg

LM Start	0.02	Rating **	M	Issue No.	11
LM End	1.44	Issue Type +	Ma	Location *	LS
Category	Earthen Levee			GPS Latitude/Longitude	
				Start	End
Item	Vegetation			39.298495 °	39.295257 °
				-121.569508 °	-121.546742 °
DWR ID	DWR_NA0006_01_f_2019_11				
Comment Code					
V1 : Control annual grass and weeds on the levee slopes and easements.					
Inspector Comment					
The annual vegetation on the landside has not been maintained this season, Fall 2019.

View looking downstream landside at the unmaintained annual vegetation, Fall 2019.

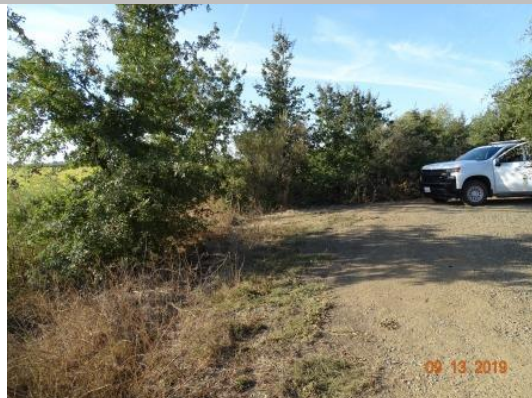
Photo 1 of 1 : FA\_2019\_NA0006\_252\_13\_20190916\_00033.jpg

LM Start	0.02	Rating **	U	Issue No.	13
LM End	0.02	Issue Type +	Ma	Location *	LS
Category	Earthen Levee			GPS Latitude/Longitude	
				Start	End
Item	Trim / Thin Trees			39.298493 °	39.298493 °
				-121.569506 °	-121.569506 °
DWR ID	DWR_NA0006_01_f_2019_13				
Comment Code					
T2 : Thin trees to allow visibility of the ground and room to flood fight.					
Inspector Comment					
There are trees that need the limbs trimmed up 5' for visibility and access on the landside, Fall 2019.

View looking downstream of trees that need the limbs trimmed up 5' for visibility and access on the waterside, Fall 2019.

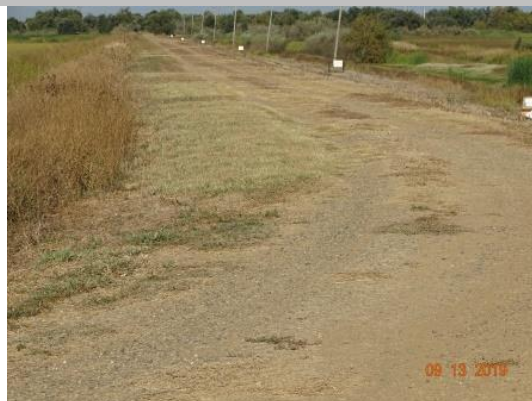
Photo 1 of 1 : FA\_2019\_NA0006\_252\_21\_20190916\_00034.jpg

LM Start	0.02	Rating **	U	Issue No.	21
LM End	0.66	Issue Type +	Ma	Location *	CR
Category	Earthen Levee			GPS Latitude/Longitude	
				Start	End
Item	Crown Surface / Depressions / Rutting			39.298504 °	39.297595 °
				-121.569502 °	-121.558310 °
DWR ID	DWR_NA0006_01_s_2015_21				
Comment Code					
C3 : Add appropriate gravel or road base. Grade and compact.					
Inspector Comment					
Place appropriate gravel on the crown roadway to make it an all weather road, Fall 2019.

View of the crown looking downstream of a section of road that needs all weather surface, Fall 2019.

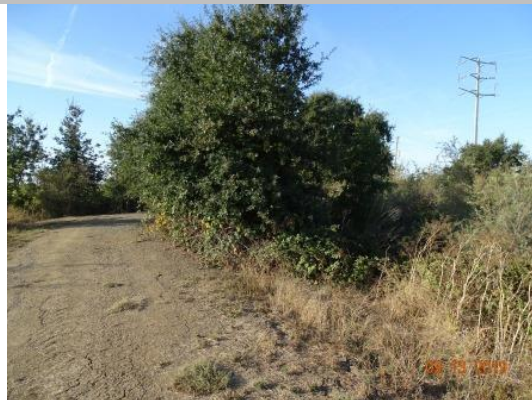
Photo 1 of 1 : FA\_2019\_NA0006\_252\_20\_20190916\_00032.jpg

LM Start	0.02	Rating **	U	Issue No.	20
LM End	0.02	Issue Type +	Ma	Location *	WS
Category	Earthen Levee			GPS Latitude/Longitude	
				Start	End
Item	Trim / Thin Trees			39.298563 °	39.298563 °
				-121.569432 °	-121.569432 °
DWR ID	DWR_NA0006_01_f_2016_20				
Comment Code					
T1 : Trim trees to at least five feet above ground level.					
Inspector Comment					
There is a tree that needs the limbs trimmed up 5' for visibility and access on the waterside, Fall 2019.

View of a tree that needs the limbs trimmed up 5' for visibility and access on the waterside looking downstream, Fall 2019.

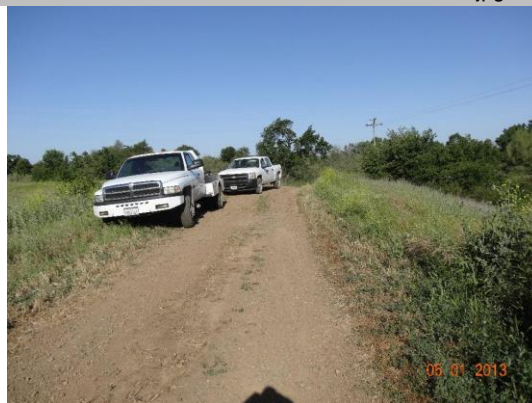
Photo 1 of 3 : UCIP\_FA\_2019\_52801\_24241.jpg

Comment Code						
Inspector Comment						
DS_ID:19168						
FS_ID:52801						
EP_NO: N/A						
Repair Type: Non-Urgent						
Crossing Status: Found						
UCIP Comments: 05/01/2013 Dense vegetation on waterward side and landward side obstructs inspection. Need to clear vegetation on slopes to conduct proper crossing evaluation. (DWR UCIP - O. Magana)						
FIELD_STRUCT_DESC: 24-inch corrugated metal drainage pipe through the levee, 10 feet below the crown. Flap gate located on the waterside (WS) end. [Additional Reference(s): DWR Levee Logs, 2005. USACE Sacramento O&M Manual Unit No. 151, November 1953, (Station 5+65)]						
FS Date: 5/1/2013

Overview of levee crown at crossing looking upstream.

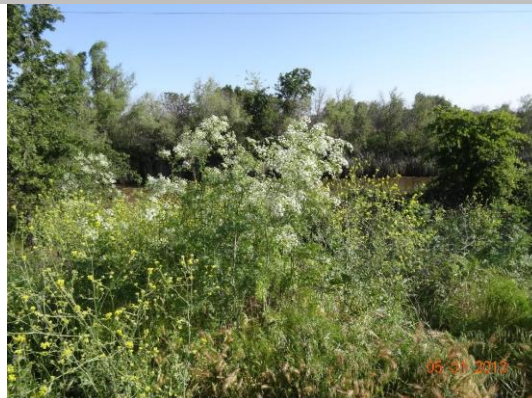
Photo 2 of 3 : UCIP\_FA\_2019\_52801\_24236.jpg

LM Start	0.09	Rating **	M	Issue No.	27 (cont)	
LM End	0.09	Issue Type +	Ma	Location *		
Category	Supplemental			GPS Latitude/Longitude		
				Start		End
Item	DRAFT DWR UCIP LMA Responsibility			39.299106 °		39.299106 °
				-121.568749 °		-121.568749 °
DWR ID	19168					
Comment Code						
Inspector Comment						
DS_ID:19168 FS_ID:52801 EP_NO: N/A Repair Type: Non-Urgent Crossing Status: Found UCIP Comments: 05/01/2013 Dense vegetation on waterward side and landward side obstructs inspection. Need to clear vegetation on slopes to conduct proper crossing evaluation. (DWR UCIP - O. Magana) FIELD_STRUCT_DESC: 24-inch corrugated metal drainage pipe through the levee, 10 feet below the crown. Flap gate located on the waterside (WS) end. [Additional Reference(s): DWR Levee Logs, 2005. USACE Sacramento O&M Manual Unit No. 151, November 1953, (Station 5+65)] FS Date: 5/1/2013

Dense vegetation obstructing waterward slope.

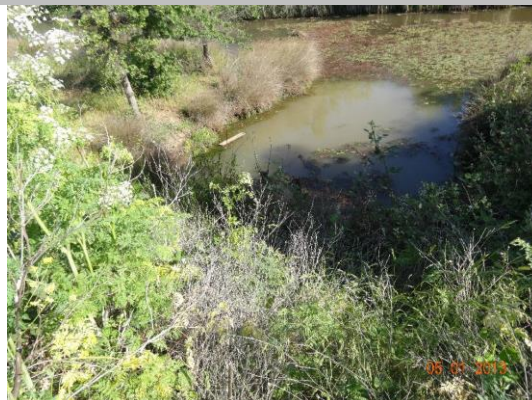
Photo 3 of 3 : UCIP\_FA\_2019\_52801\_24238.jpg

Overview of waterward side (outlet).

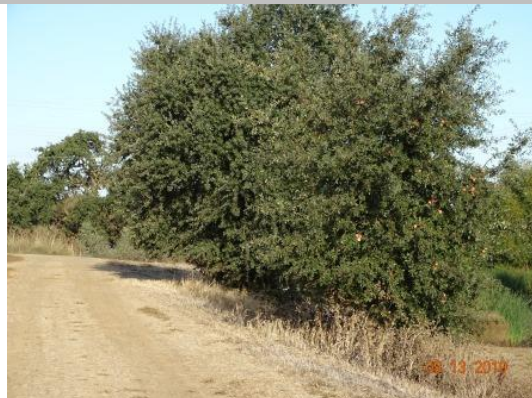
Photo 1 of 1 : FA\_2019\_NA0006\_252\_22\_20190916\_00031.jpg

LM Start	0.10	Rating **	M	Issue No.	22
LM End	0.10	Issue Type +	Ma	Location *	WS
Category	Earthen Levee			GPS Latitude/Longitude	
				Start	End
Item	Trim / Thin Trees			39.299078 °	39.299078 °
				-121.568633 °	-121.568633 °
DWR ID	DWR_NA0006_01_f_2016_22				
Comment Code					
T1 : Trim trees to at least five feet above ground level.					
Inspector Comment					
There is a tree that needs the limbs trimmed up 5' for visibility and access on the waterside, Fall 2019.

View looking downstream waterside of a tree that needs the limbs trimmed up 5' for visibility and access, Fall 2019.

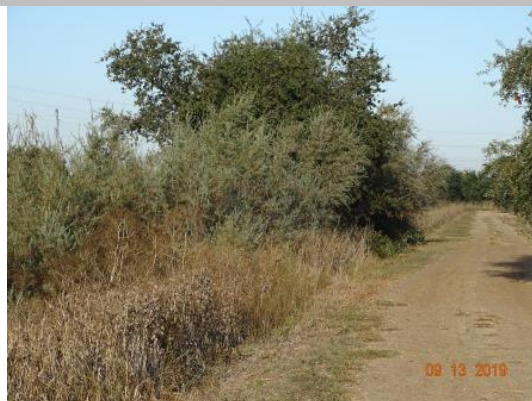
Photo 1 of 1 : FA\_2019\_NA0006\_252\_23\_20190916\_00030.jpg

LM Start	0.21	Rating **	U	Issue No.	23
LM End	0.21	Issue Type +	Ma	Location *	LS
Category	Earthen Levee			GPS Latitude/Longitude	
				Start	End
Item	Trim / Thin Trees			39.298816 °	39.298816 °
				-121.566529 °	-121.566529 °
DWR ID	DWR_NA0006_01_f_2016_23				
Comment Code					
T3 : Trim and thin trees to allow visibility of the ground and room to flood fight.					
Inspector Comment					
There are trees that need the limbs trimmed up 5' for visibility and access on the landside, Fall 2019.

View looking downstream landside of trees that need the limbs trimmed up 5' for visibility and access on the landside, Fall 2019.

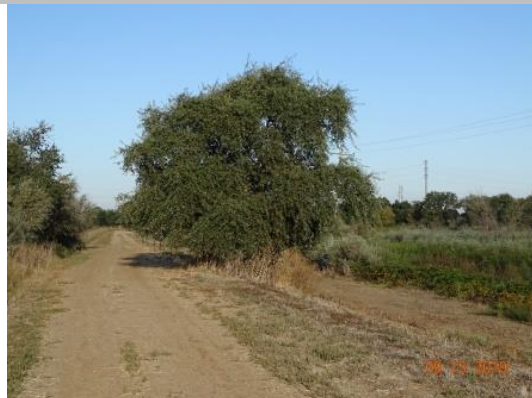
Photo 1 of 1 : FA\_2019\_NA0006\_252\_25\_20190916\_00029.jpg

LM Start	0.23	Rating **	M	Issue No.	25
LM End	0.23	Issue Type +	Ma	Location *	WS
Category	Earthen Levee			GPS Latitude/Longitude	
				Start	End
Item	Trim / Thin Trees			39.298776 °	39.298776 °
				-121.566158 °	-121.566158 °
DWR ID	DWR_NA0006_01_f_2016_25				
Comment Code					
T1 : Trim trees to at least five feet above ground level.					
Inspector Comment					
There is a tree that needs the limbs trimmed up 5' for visibility and access on the waterside, Fall 2019.

View looking downstream waterside of a tree that needs the limbs trimmed up 5' for visibility and access on the waterside, Fall 2019.

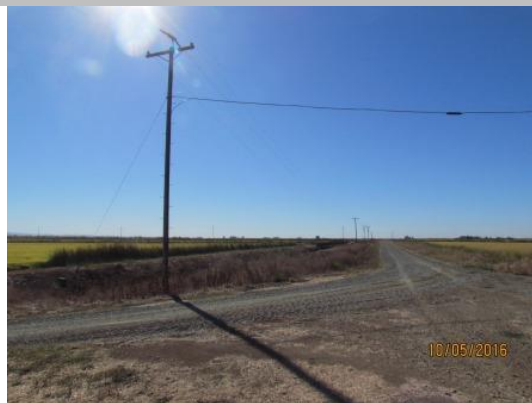
Photo 1 of 1 : FA\_2019\_NA0006\_252\_17\_20190904\_00004.jpg

LM Start	0.66	Rating **	M	Issue No.	17
LM End	1.45	Issue Type +	En	Location *	WS
Category	Earthen Levee			GPS Latitude/Longitude	
				Start	End
Item	Encroachments			39.297629 °	39.295257 °
				-121.558337 °	-121.546579 °
DWR ID	DWR_NA0006_01_s_2015_17				
Comment Code					
PO : Pole					
Inspector Comment

View of the poleline on the waterside of the levee facing upstream.

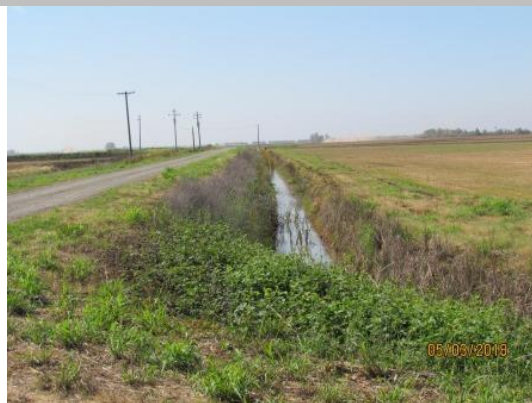
Photo 1 of 1 : FA\_2019\_NA0006\_252\_15\_20190904\_00003.jpg

LM Start	0.68	Rating **	M	Issue No.	15
LM End	1.45	Issue Type +	En	Location *	LS
Category	Earthen Levee			GPS Latitude/Longitude	
				Start	End
Item	Encroachments			39.297426°	39.295260°
				-121.558319°	-121.546719°
DWR ID	DWR_NA0006_01_s_2018_15				
Comment Code					
DT : Ditch					
Inspector Comment					
There is a ditch on the landside of the levee.

View looking upstream of landside ditch at levee toe.

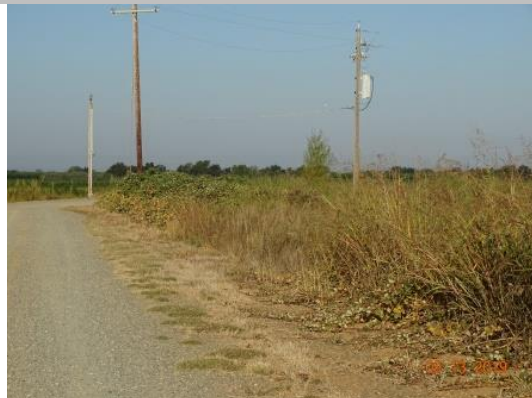
Photo 1 of 1 : FA\_2019\_NA0006\_252\_1\_20190916\_00028.jpg

LM Start	0.85	Rating **	U	Issue No.	1
LM End	0.96	Issue Type +	Ma	Location *	WS
Category	Earthen Levee			GPS Latitude/Longitude	
				Start	End
Item	Vegetation			39.294995 °	39.295021 °
				-121.557823 °	-121.555813 °
DWR ID	DWR_NA0006_01_f_2016_1				
Comment Code					
V2 : Remove the wild growth other than native grasses from the levee slopes.					
Inspector Comment					
Remove blackberry bushes that are taking over the waterside slope, Fall 2019.

View of blackberry bushes that are covering the waterside slope.  
Looking downstream waterside.

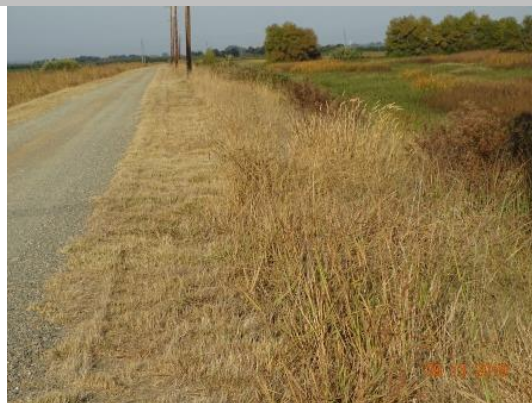
Photo 1 of 1 : FA\_2019\_NA0006\_252\_12\_20190916\_00027.jpg

LM Start	0.96	Rating **	M	Issue No.	12
LM End	1.44	Issue Type +	Ma	Location *	WS
Category	Earthen Levee			GPS Latitude/Longitude	
				Start	End
Item	Vegetation			39.295021 °	39.295257 °
				-121.555813 °	-121.546742 °
DWR ID	DWR_NA0006_01_f_2019_12				
Comment Code					
V1 : Control annual grass and weeds on the levee slopes and easements.					
Inspector Comment					
The annual vegetation on the waterside in this section has not been maintained this season, Fall 2019.

View looking downstream waterside at the section of unmaintained annual vegetation, Fall 2019.

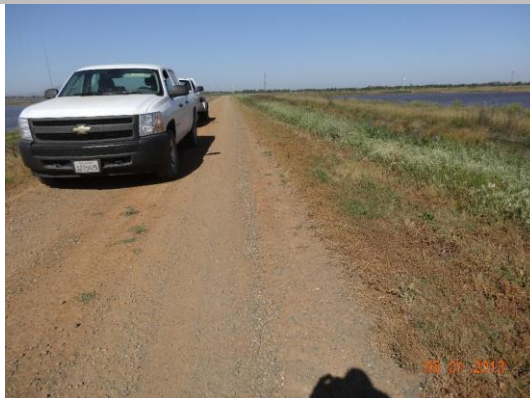
Photo 1 of 3 : UCIP\_FA\_2019\_52802\_24253.jpg

Comment Code						
Inspector Comment						
DS_ID:19172 FS_ID:52802 EP_NO: 9610 Repair Type: Non-Urgent Crossing Status: Found UCIP Comments: 05/01/2013 Scouring occuring directly across pipe on access road. Need to determine permit authorizing updates to crossing. Crossing appears to be no more than 10 years old. (DWR UCIP - O. Magana) FIELD_STRUCT_DESC: 1 of 2: 24-inch corrugated metal irrigation pipe through the levee, 6 feet below the crown. Slide gates are installed on waterside (WS) end of pipe. (two 24-inch pipe authorized Permit No. 9610, 1974-Honcut Creek Ranch). [Additional Reference(s): DWR Levee Logs, 2005. USACE Sacramento O&M Manual Unit No. 151, November 1953, (Station 53+70)] FS Date: 5/1/2013

Overview of levee crown looking upstream at crossing.

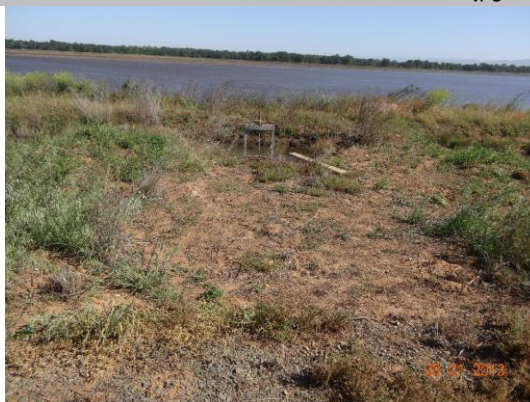
Photo 2 of 3 : UCIP\_FA\_2019\_52802\_24252.jpg

View of waterward side.

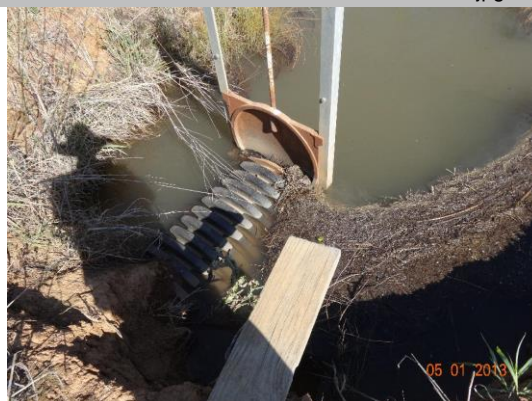
Photo 3 of 3 : UCIP\_FA\_2019\_52802\_24251.jpg

Comment Code						
Inspector Comment						
DS_ID:19172 FS_ID:52802 EP_NO: 9610 Repair Type: Non-Urgent Crossing Status: Found UCIP Comments: 05/01/2013 Scouring occuring directly across pipe on access road. Need to determine permit authorizing updates to crossing. Crossing appears to be no more than 10 years old. (DWR UCIP - O. Magana) FIELD_STRUCT_DESC: 1 of 2: 24-inch corrugated metal irrigation pipe through the levee, 6 feet below the crown. Slide gates are installed on waterside (WS) end of pipe. (two 24-inch pipe authorized Permit No. 9610, 1974-Honcut Creek Ranch). [Additional Reference(s): DWR Levee Logs, 2005. USACE Sacramento O&M Manual Unit No. 151, November 1953, (Station 53+70)] FS Date: 5/1/2013

Positive closure device on waterward side.

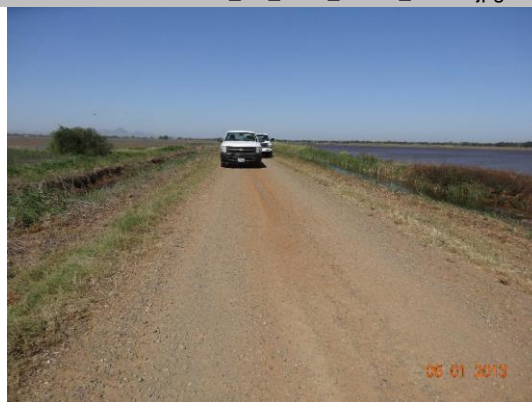
Photo 1 of 3 : UCIP\_FA\_2019\_52803\_24259.jpg

LM Start	1.17	Rating **	M	Issue No.	29
LM End	1.17	Issue Type +	En	Location *	
Category	Supplemental			GPS Latitude/Longitude	
				Start	End
Item	DRAFT DWR UCIP Field Study			39.295099 °	39.295099 °
				-121.551839 °	-121.551839 °
DWR ID	19174				
Comment Code					
Inspector Comment					
DS_ID:19174 FS_ID:52803 EP_NO: N/A Repair Type: Non-Urgent Crossing Status: Found UCIP Comments: 05/01/2013 Recent repair will need to contact owner to follow-up. (DWR UCIP - O. Magana) FIELD_STRUCT_DESC: 24-inch corrugated metal drainage pipe through the levee, 10 feet below the crown. Flap gate located on the waterside (WS). FS Date: 5/1/2013

Overview of levee crown looking upstream from crossing.

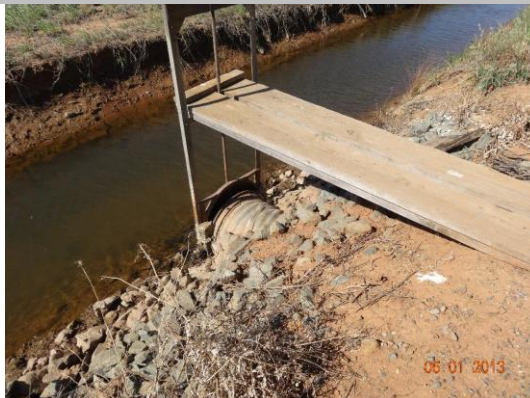
Photo 2 of 3 : UCIP\_FA\_2019\_52803\_24258.jpg

LM Start	1.17	Rating **	M	Issue No.	29 (cont)
LM End	1.17	Issue Type +	En	Location *	
Category	Supplemental			GPS Latitude/Longitude	
				Start	End
Item	DRAFT DWR UCIP Field Study			39.295099 °	39.295099 °
				-121.551839 °	-121.551839 °
DWR ID	19174				
Comment Code					
Inspector Comment					
DS_ID:19174 FS_ID:52803 EP_NO: N/A Repair Type: Non-Urgent Crossing Status: Found UCIP Comments: 05/01/2013 Recent repair will need to contact owner to follow-up. (DWR UCIP - O. Magana) FIELD_STRUCT_DESC: 24-inch corrugated metal drainage pipe through the levee, 10 feet below the crown. Flap gate located on the waterside (WS). FS Date: 5/1/2013

View of landward side: positive closure device, walkway, and rip rap on slope.

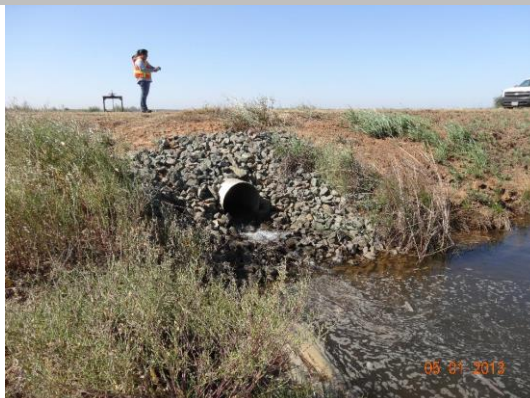
Photo 3 of 3 : UCIP\_FA\_2019\_52803\_24257.jpg

View of waterward side crossing looks fairly new.

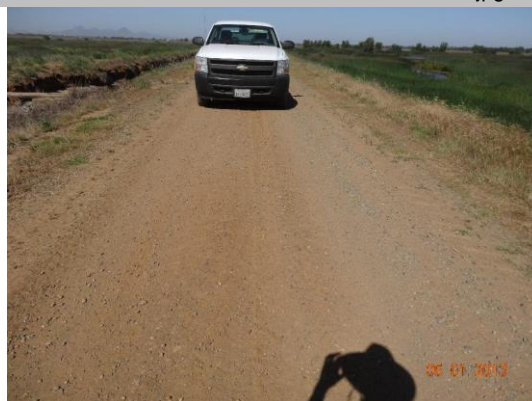
Photo 1 of 3 : UCIP\_FA\_2019\_52804\_24275.jpg

LM Start	1.44	Rating **	M	Issue No.	30
LM End	1.44	Issue Type +	En	Location *	
Category	Supplemental			GPS Latitude/Longitude	
				Start	End
Item	DRAFT DWR UCIP Field Study			39.295238 °	39.295238 °
				-121.546755 °	-121.546755 °
DWR ID	19169				
Comment Code					
Inspector Comment					
DS_ID:19169					
FS_ID:52804					
EP_NO: N/A					
Repair Type: Non-Urgent					
Crossing Status: Found					
UCIP Comments: 05/01/2013 Need to determine permit authorizing work. (DWR UCIP - O. Magana)					
FIELD_STRUCT_DESC: 18-inch corrugated metal irrigation pipe through the levee, 8 feet below the crown. Slide gate located on the landside (LS) end. Rock revetment on the LS near slide-gate.					
[Additional Reference(s): DWR Levee Logs, 2005]					
FS Date: 5/1/2013

View of levee crown looking upstream at crossing.

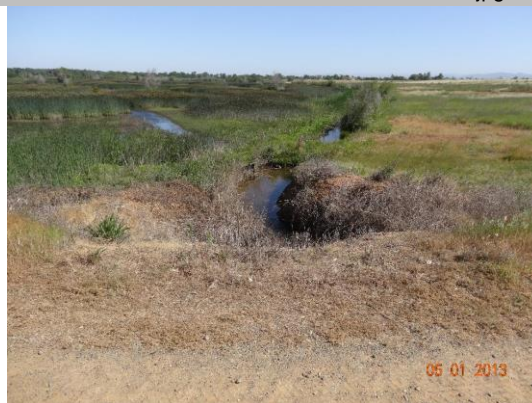
Photo 2 of 3 : UCIP\_FA\_2019\_52804\_24272.jpg

View of waterward side.

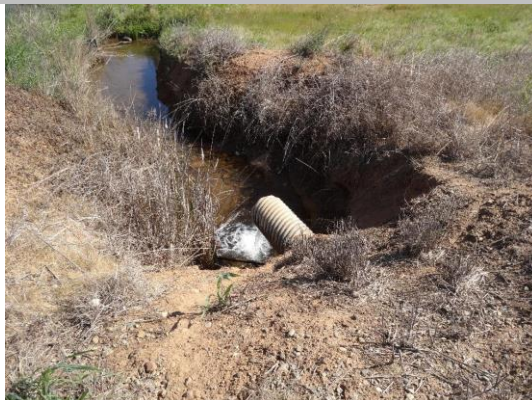
Photo 3 of 3 : UCIP\_FA\_2019\_52804\_24274.jpg

LM Start	1.44	Rating **	M	Issue No.	30 (cont)	
LM End	1.44	Issue Type +	En	Location *		
Category	Supplemental			GPS Latitude/Longitude		
				Start	End	
Item	DRAFT DWR UCIP Field Study			39.295238 °	39.295238 °	
				-121.546755 °	-121.546755 °	
DWR ID	19169					
Comment Code						
Inspector Comment						
DS_ID:19169						
FS_ID:52804						
EP_NO: N/A						
Repair Type: Non-Urgent						
Crossing Status: Found						
UCIP Comments: 05/01/2013 Need to determine permit authorizing work. (DWR UCIP - O. Magana)						
FIELD_STRUCT_DESC: 18-inch corrugated metal irrigation pipe through the levee, 8 feet below the crown. Slide gate located on the landside (LS) end. Rock revetment on the LS near slide-gate.						
[Additional Reference(s): DWR Levee Logs, 2005]						
FS Date: 5/1/2013

Crossing visible on waterward side.
